Evaluation Of Permanent Deformation On Uphill And Downhill Section Of Simpang Ampek - Sasak Road In Pasaman Barat

^{1, 2, 3, 4, 5}Civil Engineering, Universitas Malikussaleh

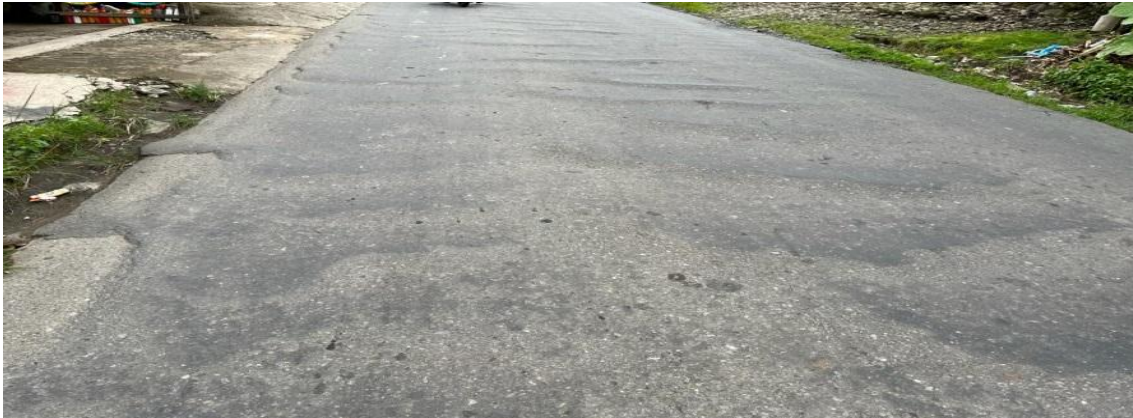
The case study identified overloading as the primary cause of road damage on the Simpang Ampek - Sasak section. Primary data revealed wavy damage (Figure 3.1) covering $3.0 \text{ m} \times 5.4 \text{ m}$, with a 7 m slope length. The total observed road area was 38.5 m^2 ($5.5 \text{ m} \times 7 \text{ m}$).

- Damage area: $3.0 \text{ m} \times 5.4 \text{ m} = 16.2 \text{ m}^2$
- Percentage of damage (N_p): 42.08%, categorized as "Large" ($N_p = 7$).
- Damage weight (N_j): 6.6 for wavy damage.
- Total damage (N_r): $7 \times 6.6 = 46.2$, classified as "Many."

Figure 1. Wavy Damage to Flexible Pavement (Researcher)

Further research should focus on road damage repair methods to address these issues. To control the level of road damage, enhanced field supervision is recommended to monitor and regulate vehicle loads passing through this section. Immediate attention and repairs are needed for the Simpang Ampek - Sasak road to ensure safer and more comfortable driving conditions for users, while preventing further deterioration of road smoothness and more severe damage in the future.
